Evanston's Leak Detection Program

Cost Savings & Many Other Benefits

PCCP Large Diameter Water Main Inspection

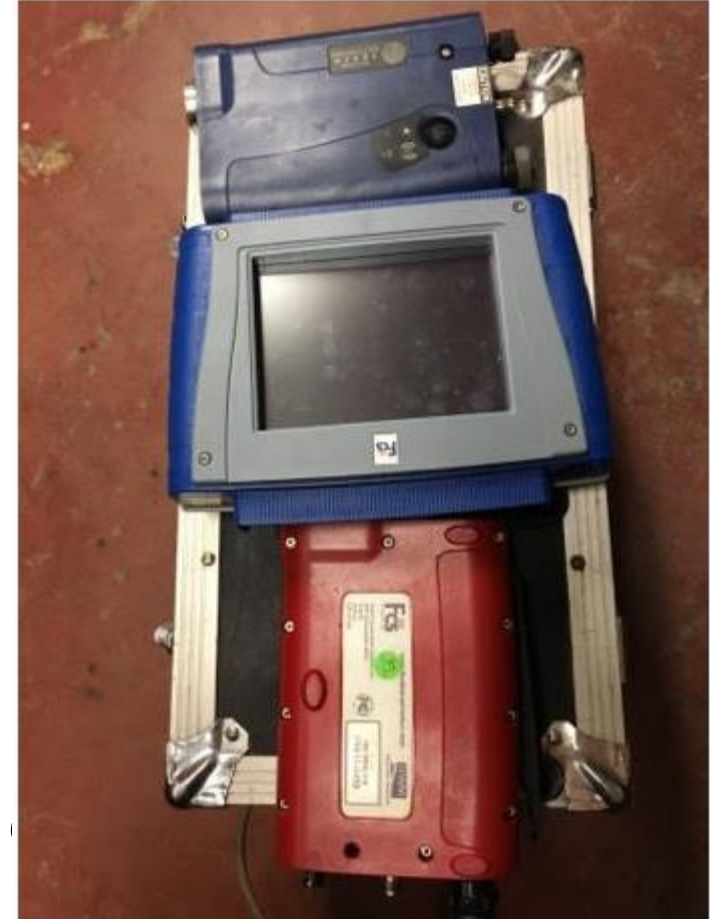
Previous Program: Correlator Only

- Correlator captures the sound of water escaping from a pipe
- Correlation is all-day work, can't multi-task
- Traffic, major water usage, other utilities can interfere
- ***Result: Proactive leak detection was limited to 3-4 miles per year, 2% of the distribution system***

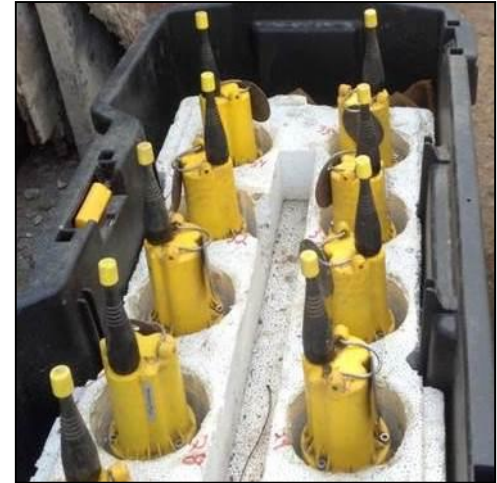
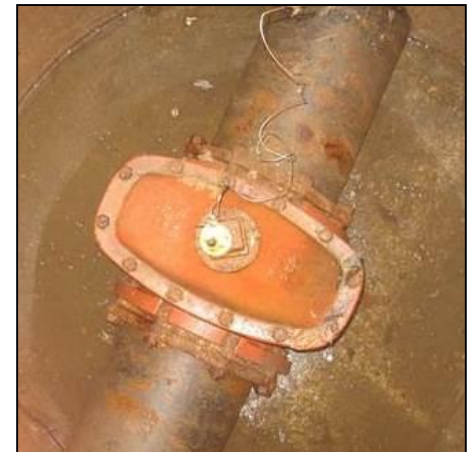
New Program: Loggers (First)

- Loggers only detect presence or absence of leak “noise”
- Logger deployment can be done in between other tasks
- Loggers fit in valve vaults and boxes, can be left overnight

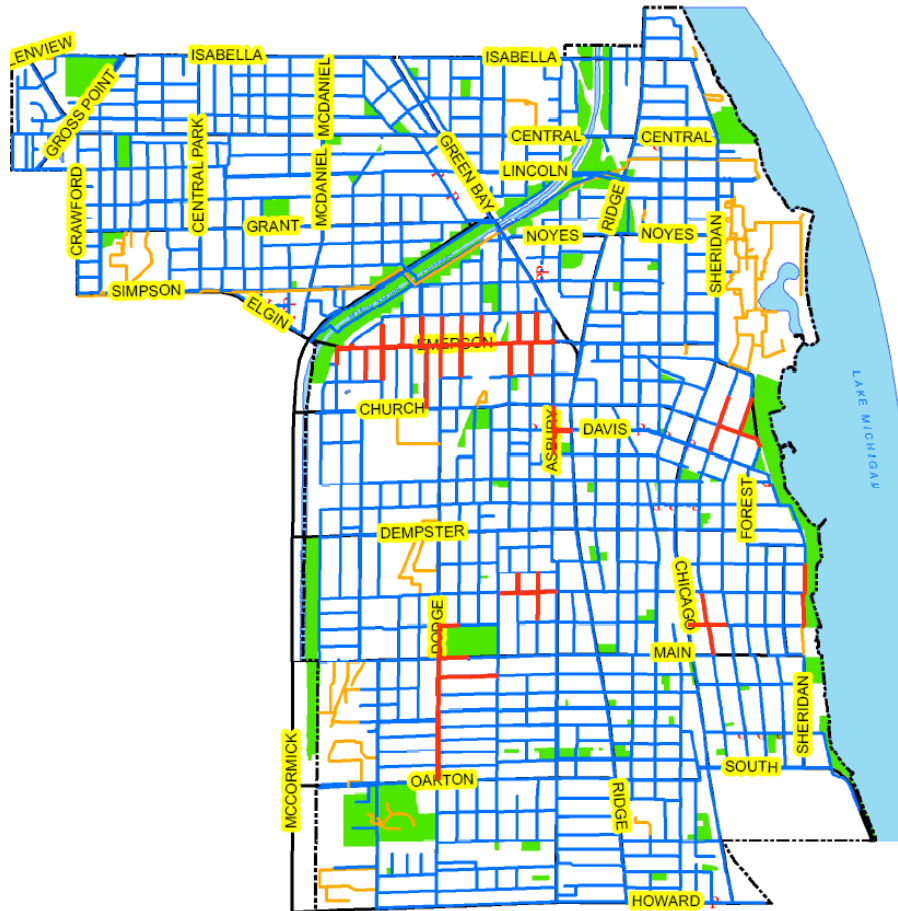
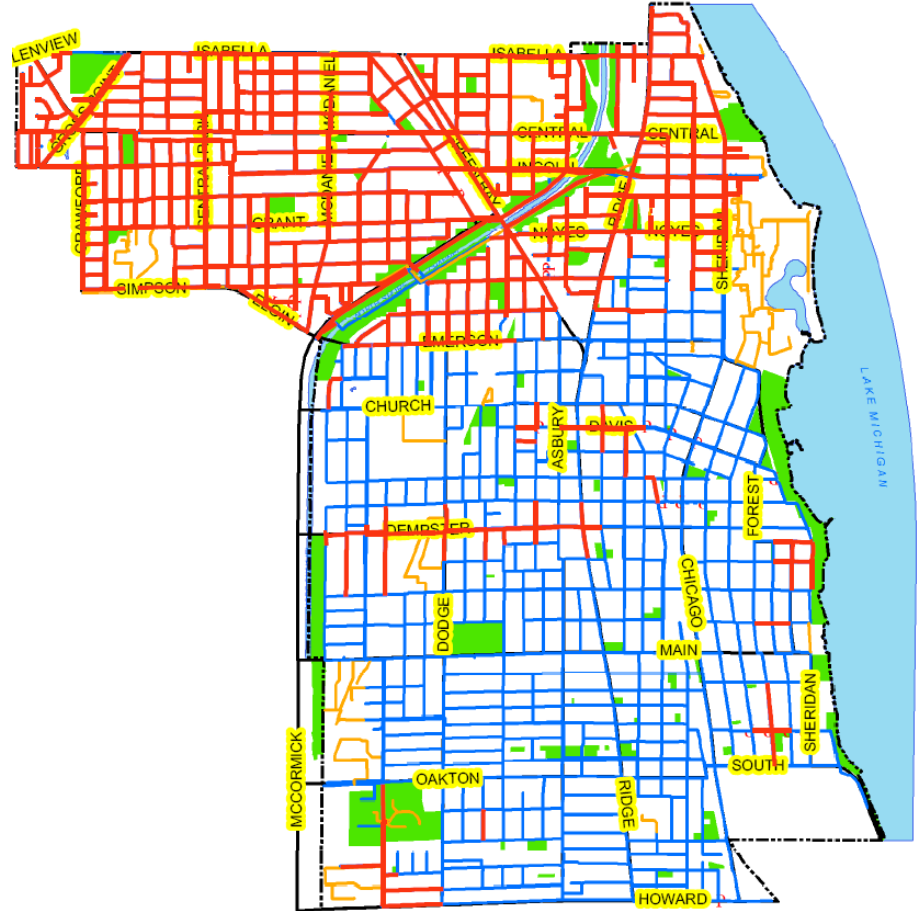
Previous Program

2013-2014 Program

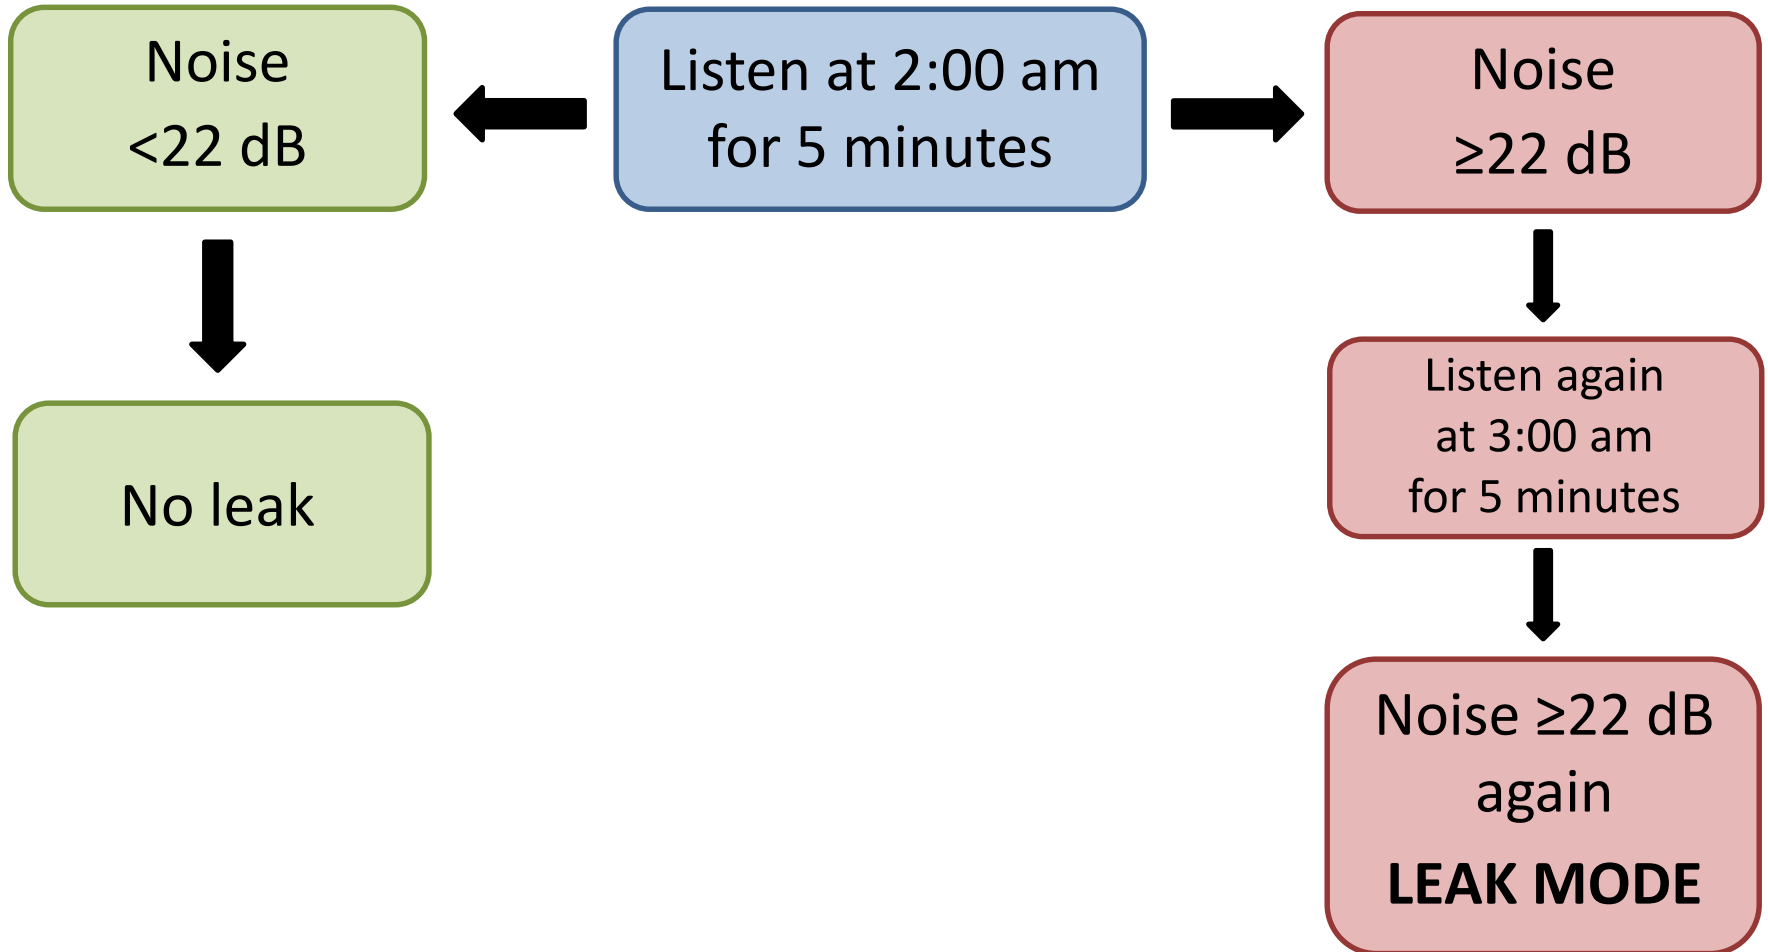
Leak Surveying with Loggers

Step 2: Loggers listen for leak noise

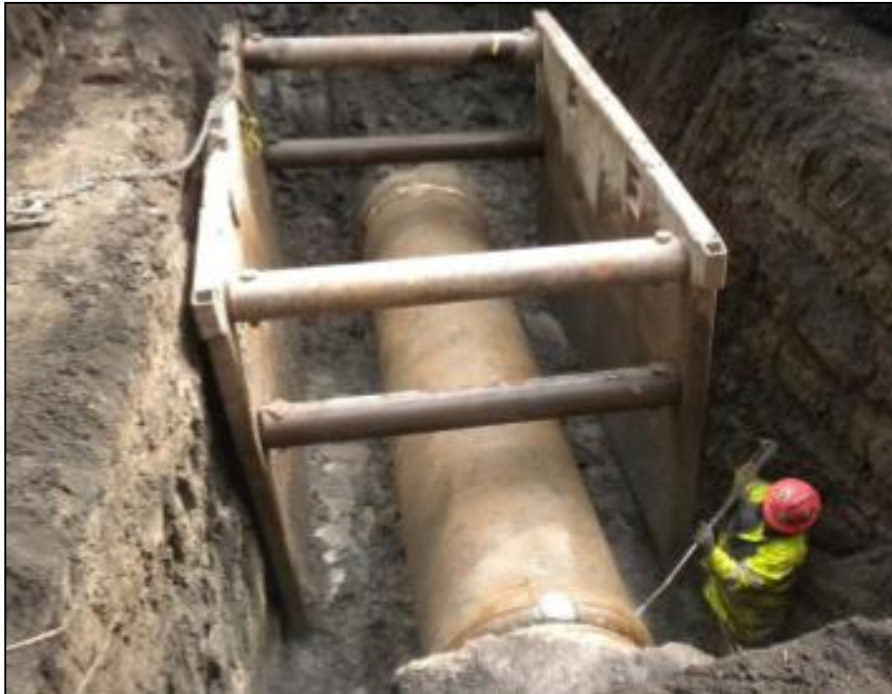
1. Limited In Trench Inspection and Dissection

- Inspected 16 foot long section (0.2%)

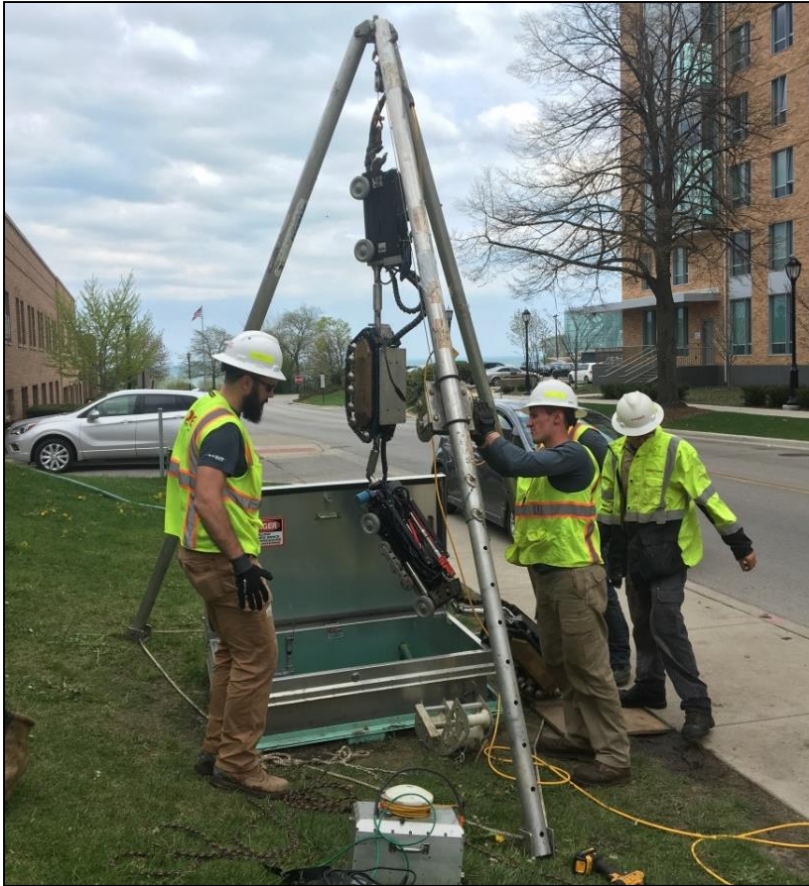
2. Non-Destructive Internal Evaluation

- Inspected ~12,954 ft. (71%)

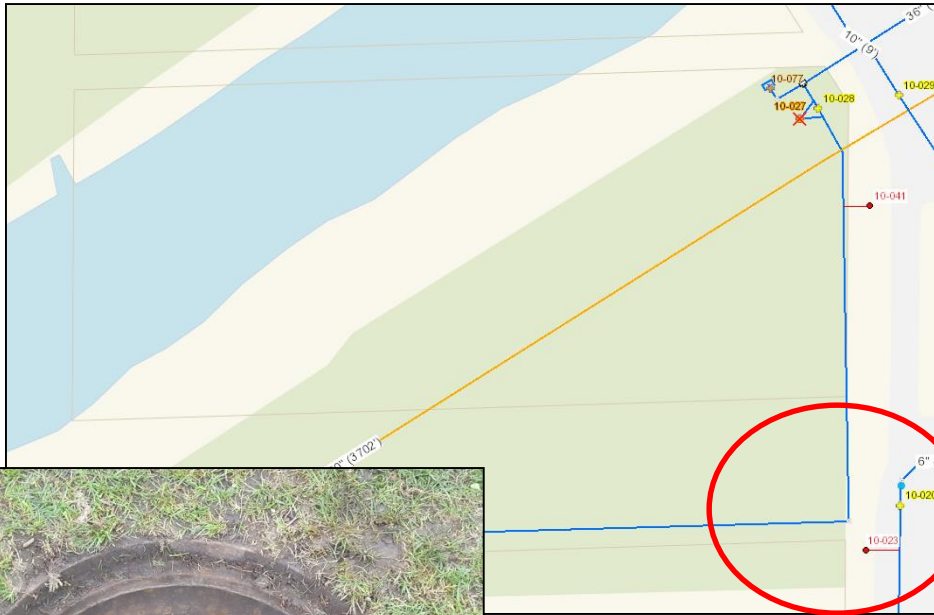
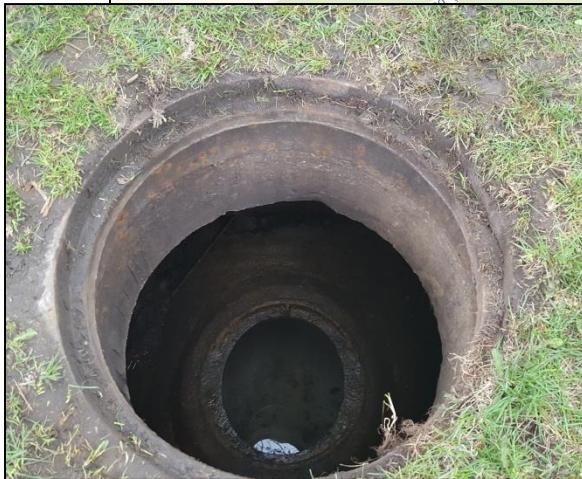
Challenges to Inspection

- Bends and valves
- Insertion points

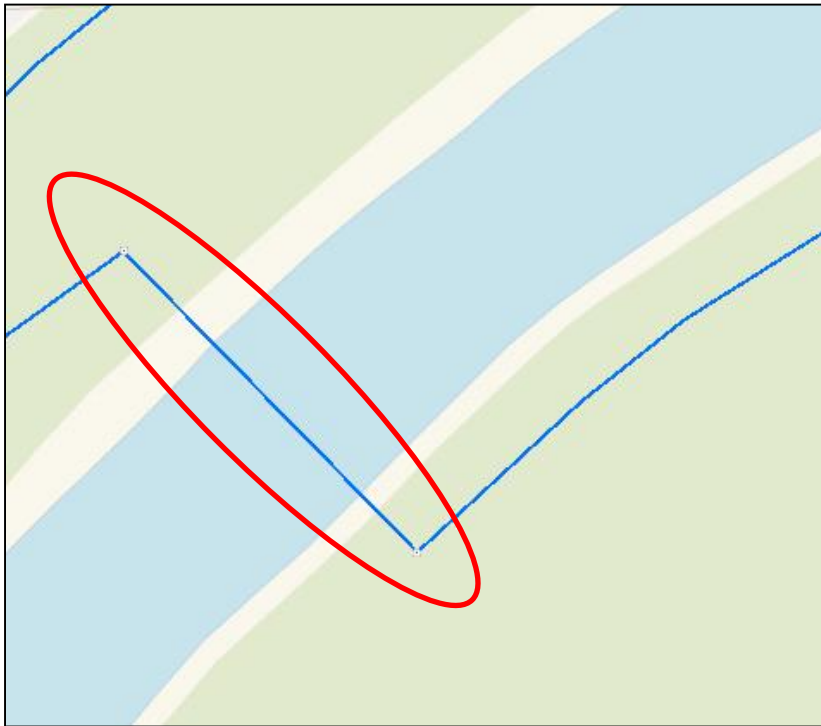
Challenges to Inspection

- Changes in elevations
- Pipeline hydraulics

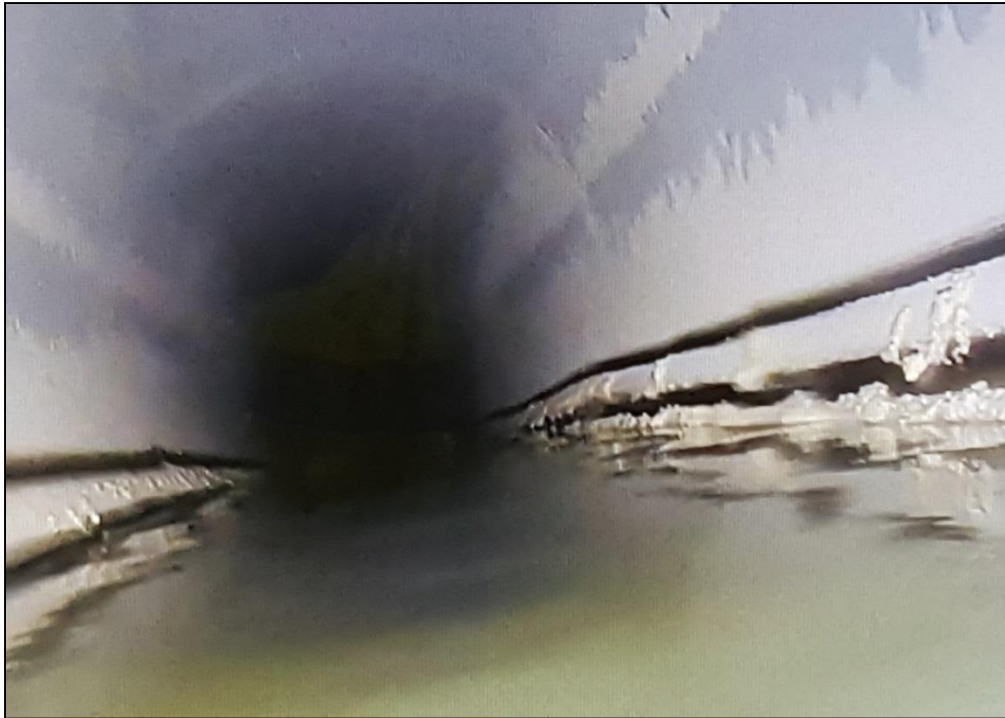
Challenges to Inspection

- Control of water
- Phosphate disturbance

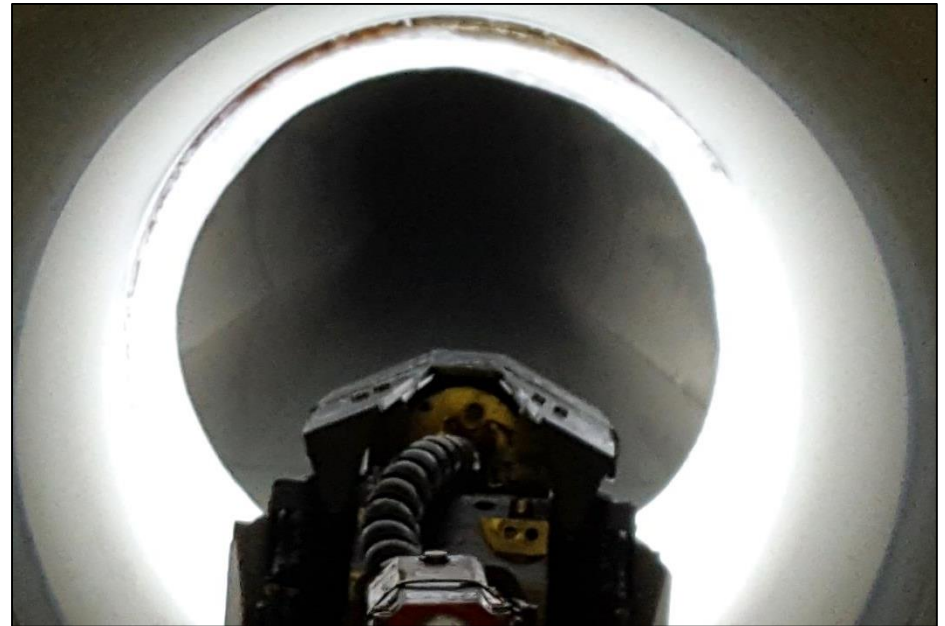
Findings

Overall good condition
